# UNDERWATER BRIDGE INSPECTION REPORT

STRUCTURE NO. 2796

10<sup>TH</sup> AVENUE

MISSISSIPPI RIVER

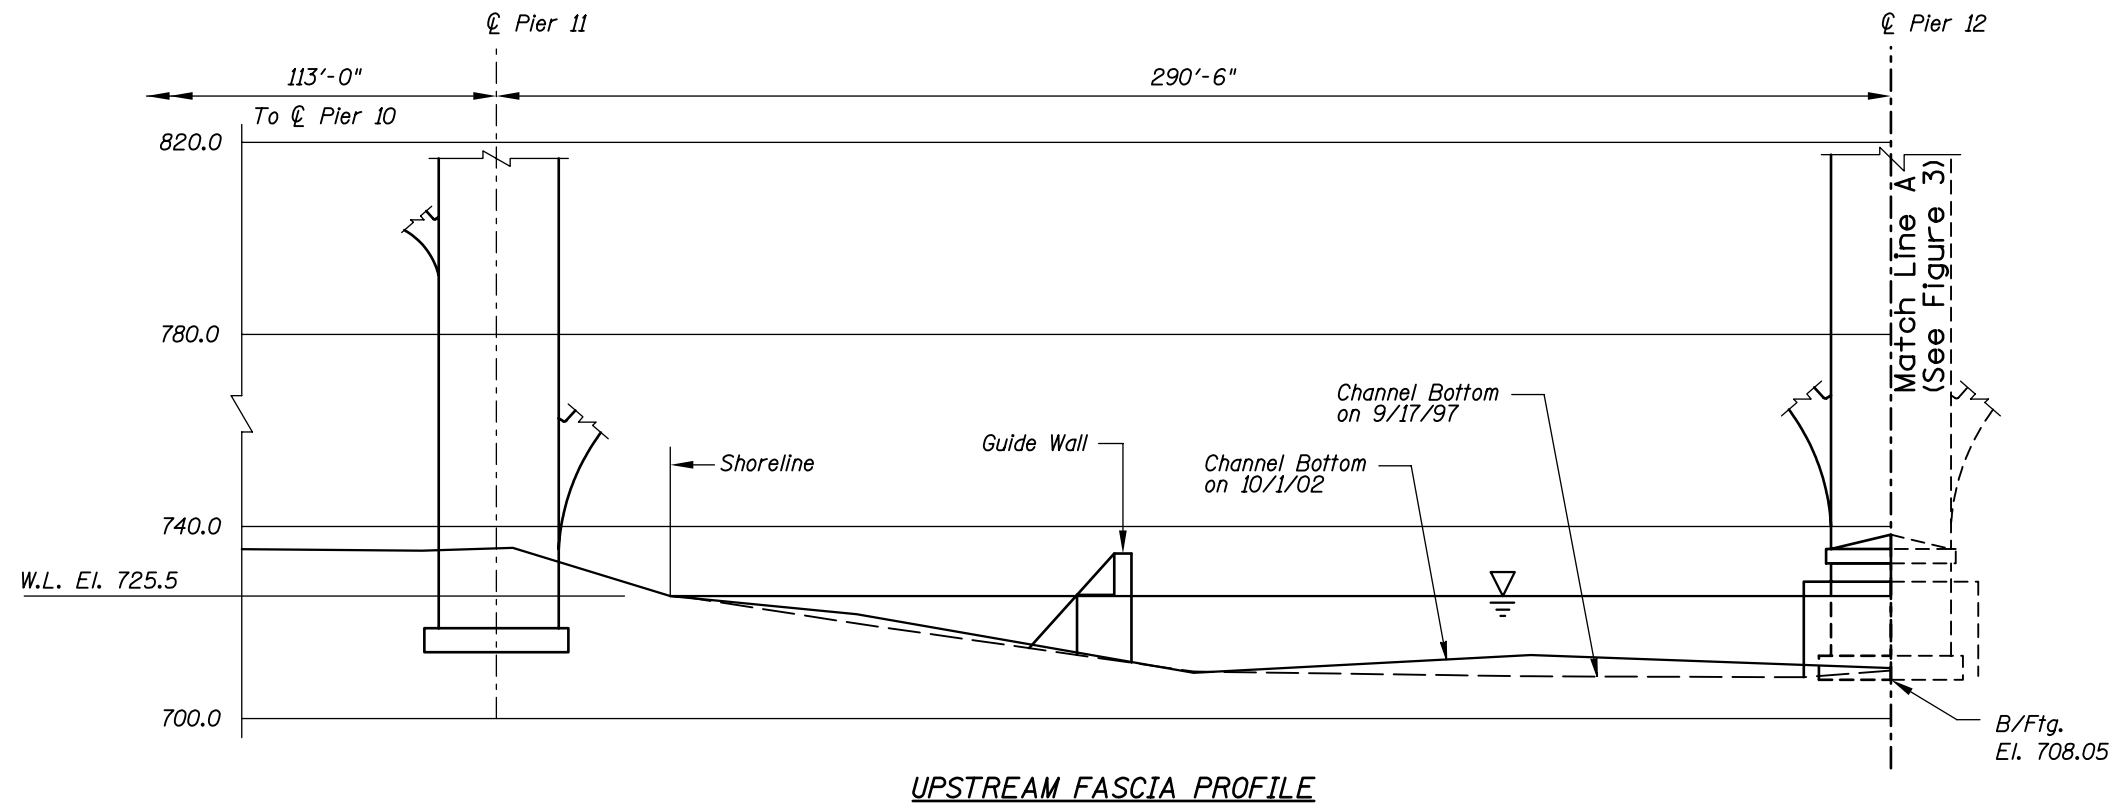
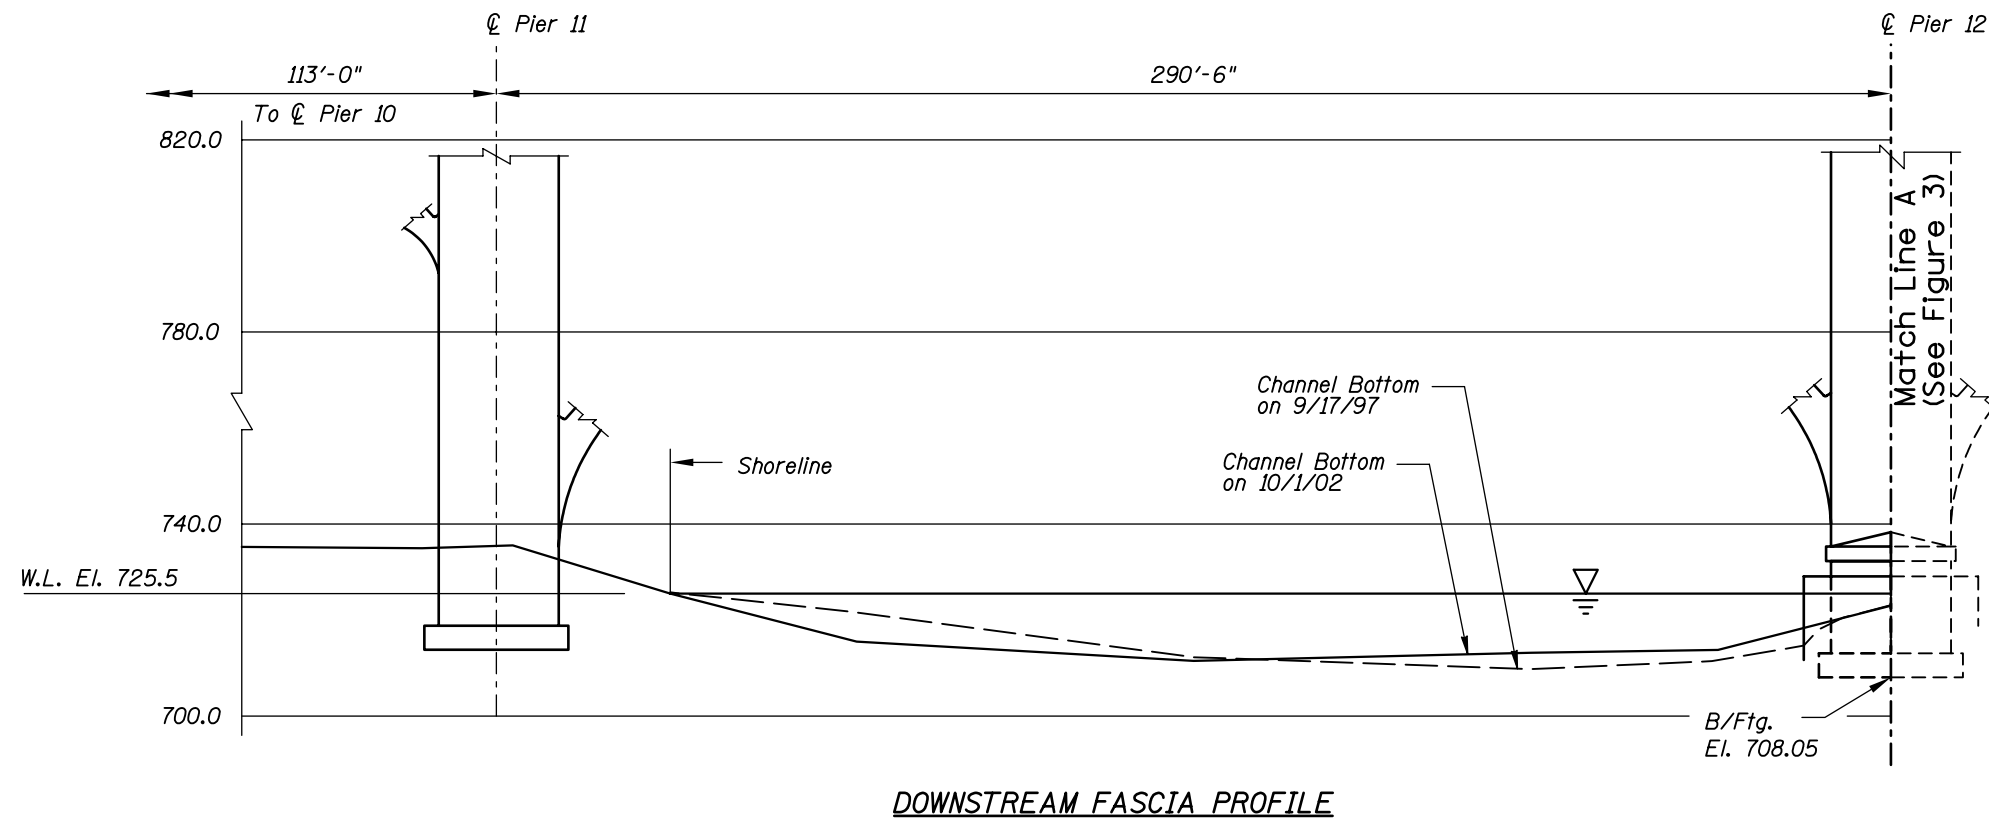
#### INSPECTION AND SOUNDING PLAN

- 2 The channel bottom material consisted of a sandy gravel with 4 inches of probe rod penetration.
- 3 Gaps in the lines of construction (not at interlocks), were observed in the steel sheeting at the east and west upstream 1/4 points with maximum widths located at the channel bottom. The west gap measured 15 inches in width and had a maximum penetration of 6 inches. The east side gap measured 36 inches in width and had no penetration.

- 4 A void between the horizontal C-channels and the vertical sheeting was observed at the east side upstream 1/4 point of the pier at 2.5 feet below the waterline with a height of 2.5 feet and 2 feet of maximum penetration.

- 5 The steel sheeting was in good condition with a uniform 1/8 inch layer of surface corrosion extending from the top of the sheeting to the channel bottom.
